REPORT OF INVESTIGATION

Surface Coal Facility

Slip or Fall of Person
November 4, 2007
(Victim Died January 2, 2008)

Remington Preparation Plant
Weatherby Processing Corp.
Ohley, Kanawha County, West Virginia
MSHA I. D. 46-08685

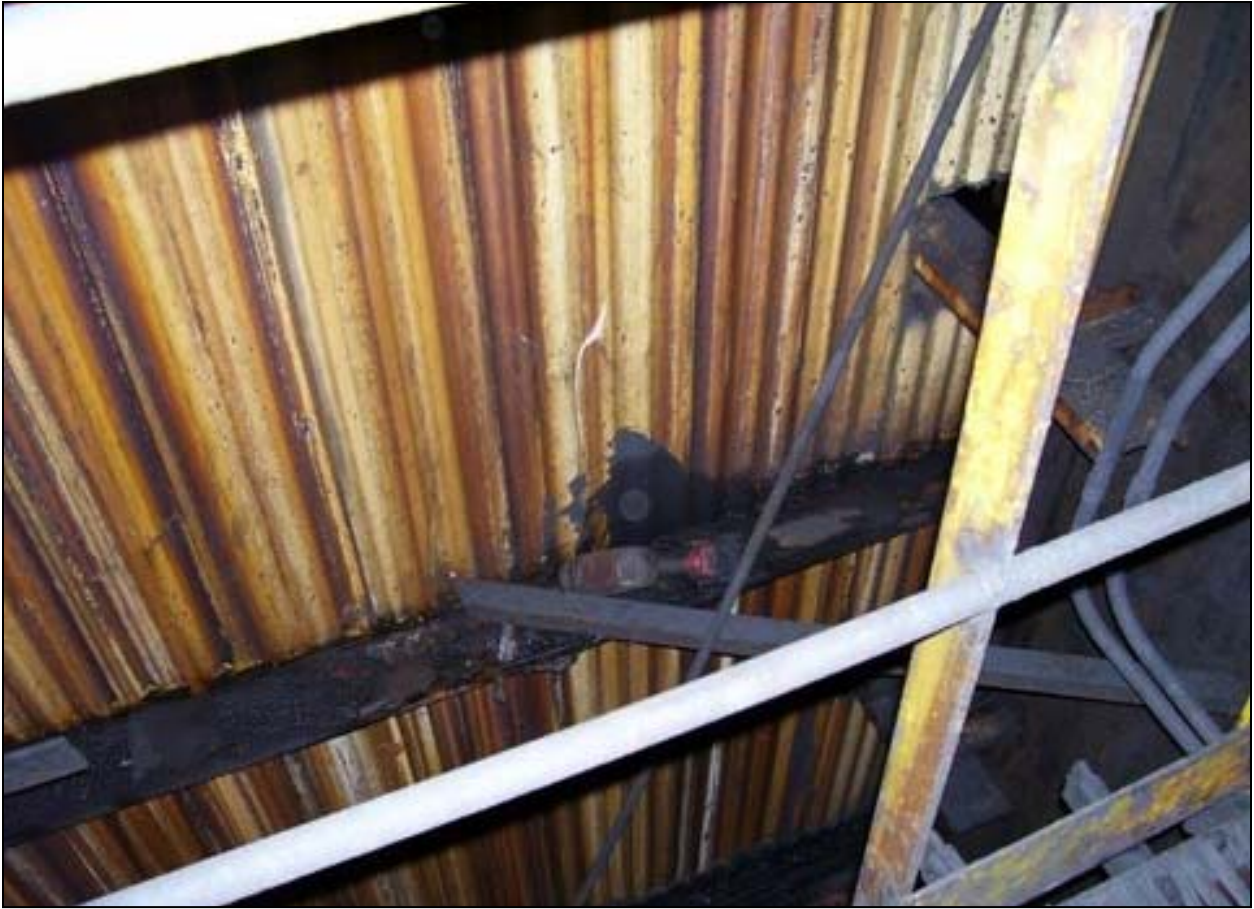
PHOTOGRAPH OF ACCIDENT SCENE

An open area measuring 3.4 feet existed between the walkway and the 6-inch channel where the impact wrench laid. The channel was 1.8 feet below the floor of the third floor walkway. The floor of the walkway on the third floor was 19.4 feet above the first floor. A standard 42-inch high steel handrail (guard) was securely in place along the entire length of the open side of the walkway. The center railing was 2 feet above the walkway and the toe plate extended 5-inches above the walkway.

The walkway at the work site on the third floor was in good condition. A standard securely anchored handrail existed along the entire length on the open side of the walkway. The top steel rail of the handrail structure measured 42 inches above the floor of the walkway. The center railing and tow plate were 2 feet and 5 inches above the walkway, respectively. An open area existed between the walkway and the exterior east wall of the preparation plant measuring approximately 18.2 feet in length and 3.4 feet in width. The distance from the walkway of the third floor to the floor of the first floor measured 19.4 feet. The distance from the 6-inch channel that the impact wrench fell onto and the toe guard of the walkway measured 3.4 feet. The 6-inch channel was 1.8 feet below the surface of the third floor walkway.

Root Cause: A safe procedure, using fall protection, was not followed in retrieving the impact wrench. The victim could only have fallen by climbing over or through the railing. The victim was not wearing fall protection.

Corrective Action: The mine operator submitted an addendum to the Part 48 training plan on November 6, 2007. The addendum addresses the use of fall protection where persons are working in surface installations through which persons may fall. The addendum will be incorporated in all Newly Employed Training, Annual Retraining, Hazard Training, and Contractor Training.
